RTO AGARDograph

AG-AVT-140

Corrosion Fatigue and Environmentally Assisted Cracking in Aging Military Vehicles

This AGARDograph has been sponsored by the
Applied Vehicle Technology Panel of RTO.

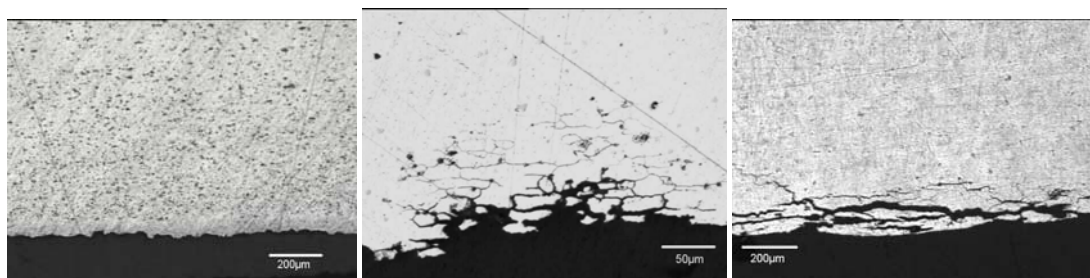
(a) Images from naturally corroded 2024-T3 fuselage lap joints.

Figure 4-1: Optical Micrographs Showing the Modified Discontinuity States from Naturally Corroded Components that were Progressively Polished.

The only technique that is capable of characterizing the different damage states present for all types of corrosion (pitting, exfoliation, intergranular, etc.) is optical microscopy [1],[2]. To document the damage, sections should be taken from the affected areas, cold mounted and progressively polished using standard metallurgical practices, examples of which are shown in Figure 4-1. It is essential to mount the sections for polishing using a cold resin in order not to affect the corrosion damage.

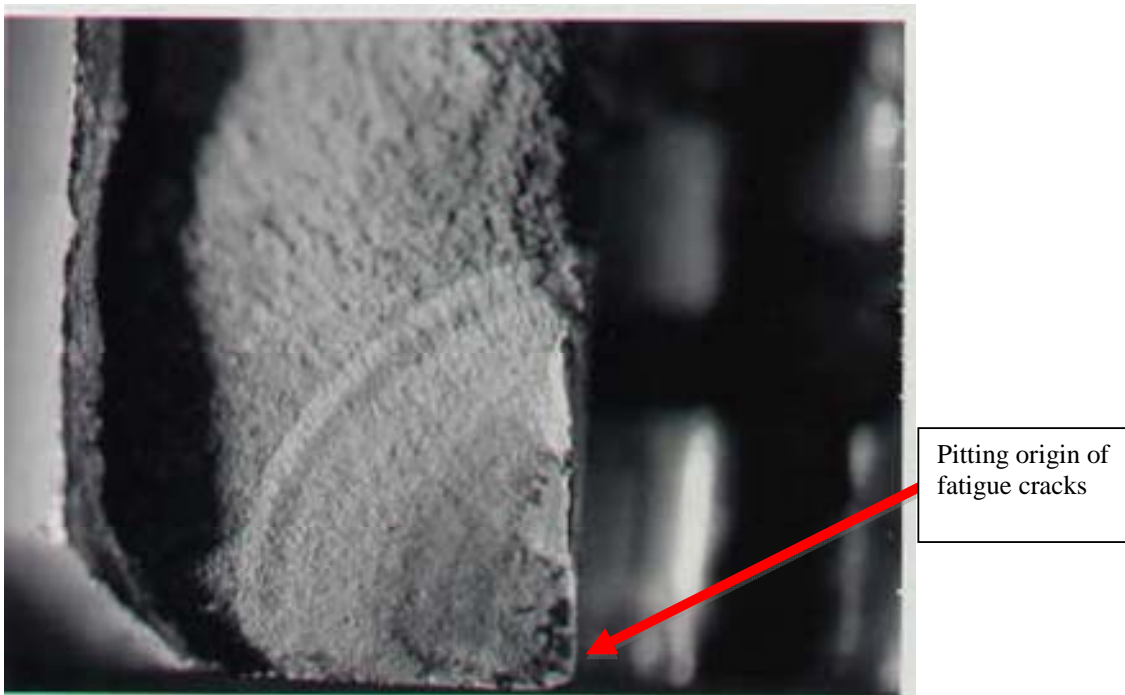
Figure 5-4: Fracture Surface of C130 "Porkchop" Fitting that Unexpectedly Failed from Pitting that Transitioned into Cracks.

(Photo by Ms. Amy Taylor, and David W. Hoepfner, University of Utah, 1999. Crack started at a pit at the lower right corner and propagated by corrosion fatigue mechanisms. This was commonly observed.)

The following is an example of unexpected pitting corrosion on a “non-critical component” detected in service. The C130 aircraft, used in many countries throughout the world, was found to have cracking in a fitting that is in the rear of the aircraft and is referred to as either the “Porkchop” fitting or the “hockey stick fitting”. Which reference is used is a function of the country in which the problem was discovered. Some indicated the problem was due to stress corrosion. This is not viewed likely since the component experiences cyclic loads. When both DND, Canada, and the New Zealand forces were experiencing cracking of the component they decided to have competent failure analysis labs evaluate the cracked fittings further. Thus, the Aerospace and Maritime Research Laboratory (AMRL) in Melbourne, Australia and the Quality Engineering Test Establishment (QETE) in Gatineau, Quebec, Canada performed failure analyses on the subject components. Additional failure analysis was done by the University of Utah Quality and Integrity Design Laboratory (QIDEC) and IAR (Institute of Aerospace Research) in Ottawa, Ontario, Canada. Figure 5-4 and Figure 5-5 show two views of the pits that nucleated the fatigue cracks. In addition, growth rings typical of fatigue, in this case most likely environmentally assisted fatigue crack propagation, are also clearly apparent. AMRL and QETE were both helpful in identifying the true failure mode in this case. The subject component had not been identified as a structurally significant item. The cracking was found initially by diligent maintenance personnel. Subsequent to the discovery of the corrosion pitting as the source of the cracks a program was put into place to monitor the area in question for corrosion thereby preventing the rampant formation of both corrosion pits and fatigue cracking. This was a significant aid to all the forces flying this particular transport aircraft.

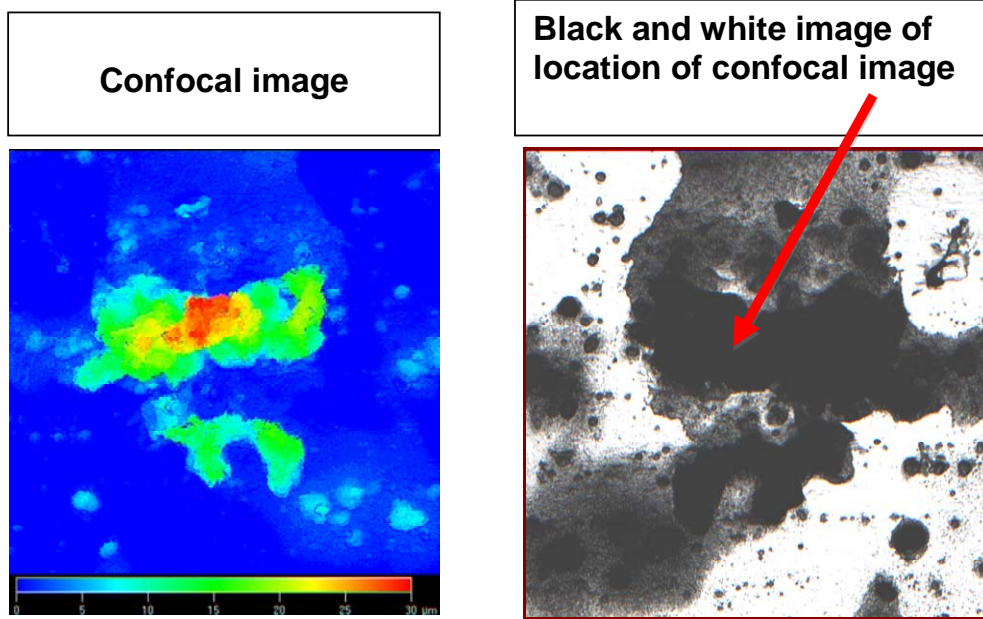
Figure 5-9: Post Corrosion Exposure of 30 Hours, d~0.0012" (30 mm) of Pit: Left image shows typical confocal image with variation in color showing depth – red indicates the deepest area of the pit; Image on right shows area where confocal image was taken.

Figure 5-9 below shows an example of an image of pits taken in a confocal microscope. The confocal microscope has been very successful in allowing the determination of pit depth and more clarity on the shape of pits as well (see Ref. [49] for more general descriptions of the use of the confocal microscope to characterize pits. This is in addition to many other references cited herein). Another example of the characterization of pits is shown in Figure 5-10. In this case the confocal microscope was used in conjunction with the SEM (Scanning Electron Microscope) to characterize the depth and shape of corrosion pits developing under corrosion fatigue test conditions. These tools proved invaluable in their ability to assist in characterizing the depth and shape for use in modeling efforts as described in Chapter 7 of this report.

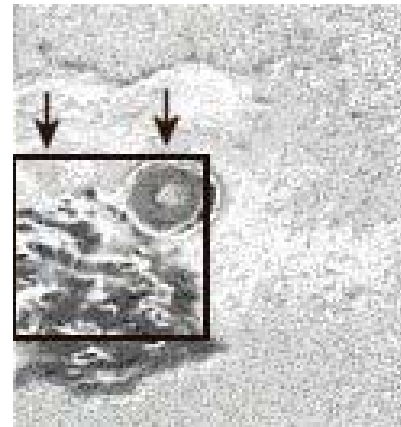
(a) Photograph of section showing locations of polishing.

(b) Ultrasonic inspection results.

Figure 6-1: Results from the Progressive Polishing Carried Out on Specimen 362-B-S4-1 that Contained Visible Exfoliation (arrows indicate the location of the deepest intergranular attack).

To document the damage caused by exfoliation corrosion, sections were taken from service exposed 7178-T6 upper wing skins from retired Boeing 707 aircraft [3]. As outlined in Chapter 4, these sections were cold mounted and progressively polished to determine the damage state. An image of this section along with the NDI and polishing results are shown in Figure 6-1. It is interesting to note how the damage morphology substantially changed over a small distance, 1.067 mm (0.042 inches), from very little intergranular corrosion to considerable amounts of exfoliation. Although very little intergranular corrosion was present below the observed exfoliation, as can be seen from the arrows in Figure 6-1, the intergranular corrosion that was present was located very close to the maximum exfoliation depth. This suggests that if this area of the wing skin was repaired the intergranular corrosion would probably also be removed.

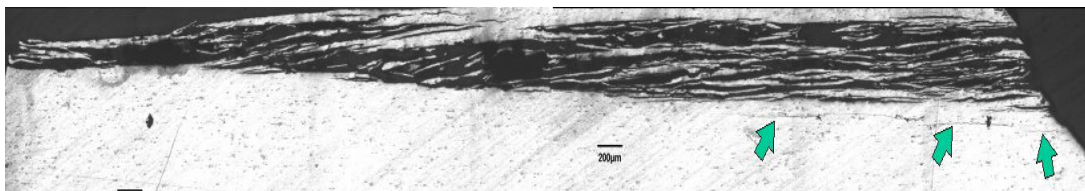
(a) Photograph of section showing locations of polishing.

(b) Ultrasonic inspection results.

(c) First polishing.

Figure 6-2: Results from the Progressive Polishing Carried Out on Specimen 362-B-S4-2 that Contained both Visible Exfoliation and a Repaired (Ground-Out) Area (arrows indicate the location of the deepest intergranular attack).

Another section that was taken from an upper wing skin contained both visible exfoliation and a repaired (ground-out) area. An image of this section along with the NDI and polishing results are shown in Figure 6-2. Although visible exfoliation was clearly present outside of the repaired area, no damage was detected within the area. It is interesting to note that as the polishing progressed the severity of the exfoliation decreased to intergranular corrosion, which extended into the repaired area. Whether the intergranular corrosion at this depth was present before the repair process was carried out could not be determined.

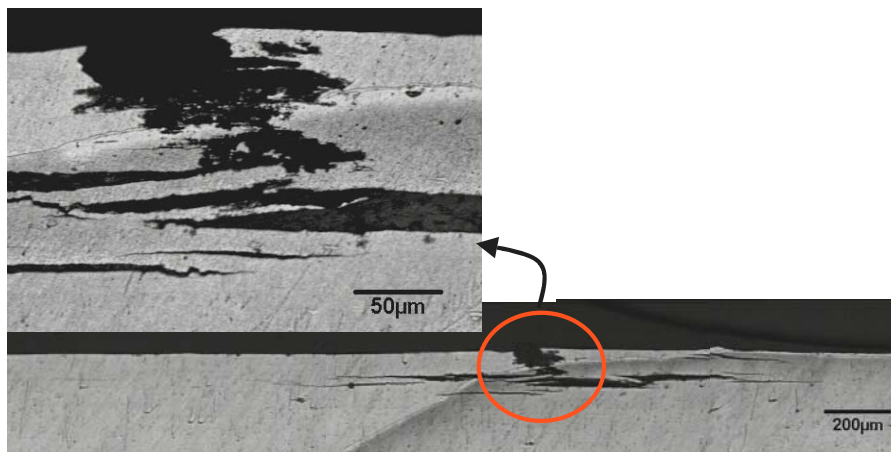
(a) Photograph of section SC5-3E.

(b) Photomicrograph of exfoliation present in section after first polish. Note presence of corrosion pit (circle).

(c) Photomicrograph of exfoliation present after second polish in same area as (b).

Figure 6-5: Exfoliation Present Along S-T Direction of Section Taken from 7075-T6 Upper Wing Skin.

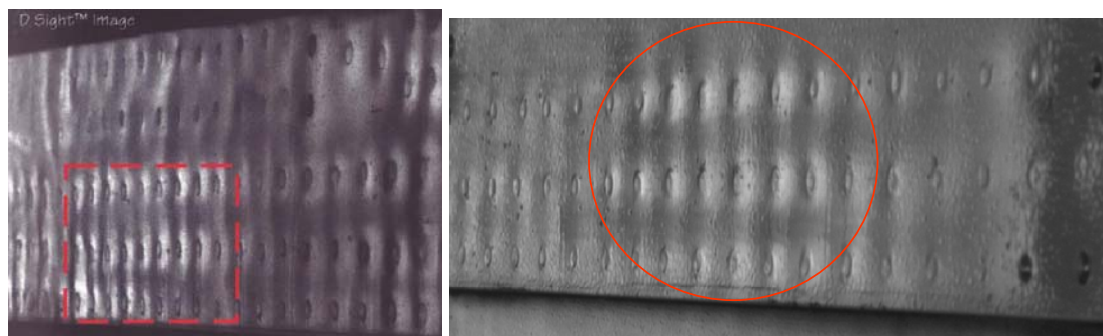
Figure 7-4: D-Sight™ Images Showing Pillowing Caused by Corrosion Products.

The most common procedure is to inspect the fuselage joints visually from the aircraft exterior. Typically inspectors look at the lap joint surfaces for traces of corrosion products, and for corrosion pillowing deformation, most often with the aid of a flashlight. Figure 7-2, Figure 7-3 and Figure 7-4 show typical images of pillowing obtained using an optical inspection method, known as D-Sight™, designed to enhance the appearance of the surface perturbations. The fundamental assumption is that corrosion is not significant unless the inspector is able to see shadows cast by the deformed surface. Unfortunately, there is no data on the Probability Of Detection (POD) for corrosion pillowing using visual inspection.

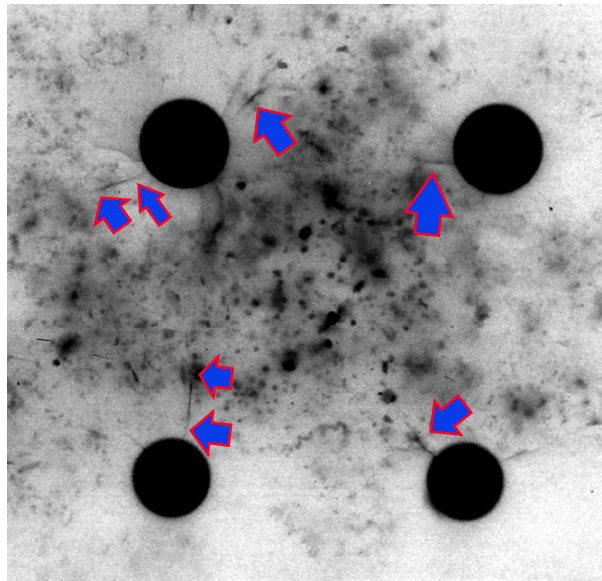
(a) Optical image of cracks in Boeing 707 longitudinal lap joints.

(b) X-ray micrograph showing cracks in L1011 lap joint.

Figure 7-6: Various Images Showing the Typical Star-Shape Pattern Associated with Pillowing Cracks.

- Pillowing cracks tended to occur in groups (i.e., “star-shape” pattern cracks at more than one rivet hole), which did not normally penetrate through the thickness. The cracks always occurred on the side of the hole that was affected by the increased stress due to the pillowing and tended to propagate into the pillowed region Figure 7-6.
- The crack faces that were pried open contained corrosion products and showed extensive intergranular fracture with numerous secondary cracking, Figure 7-7.
- A number of the cracks had multiple nucleation sites. Although these sites could not be determined, they were evidently based on the different crack planes present, Figure 7-8.

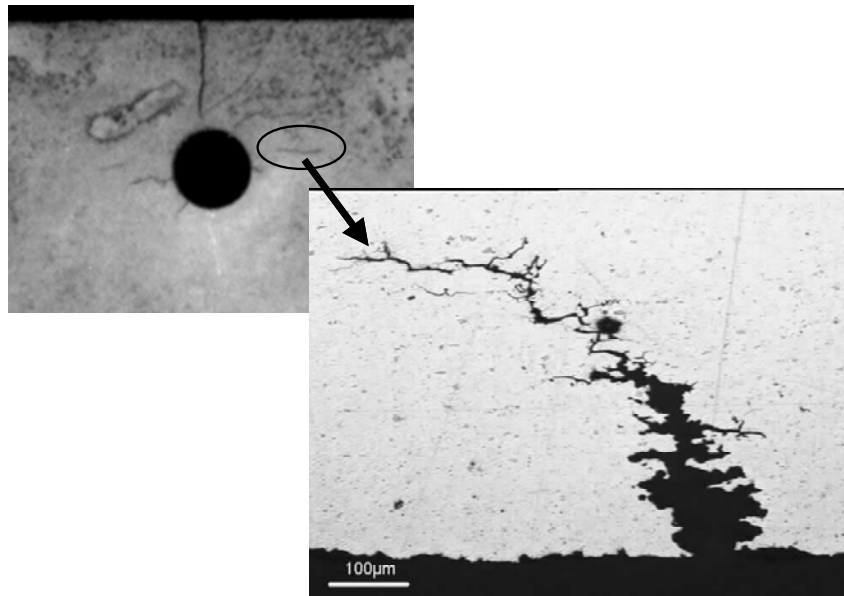
Figure 7-9: Optical Image of Pillowing Crack Showing Angled Crack Growth.
(Note that the crack occurred away from the edge of the hole but is still within the highly stressed area caused by the corrosion pillowing.)

- The crack growth through the thickness was not perpendicular to the faying and outer skin surfaces but occurred at an angle, Figure 7-9.
- Some of the fracture surfaces contained fatigue striations near the crack edge where the corrosion was light, Figure 7-10 and suggests that once these cracks form, they may continue to grow under fatigue loading.

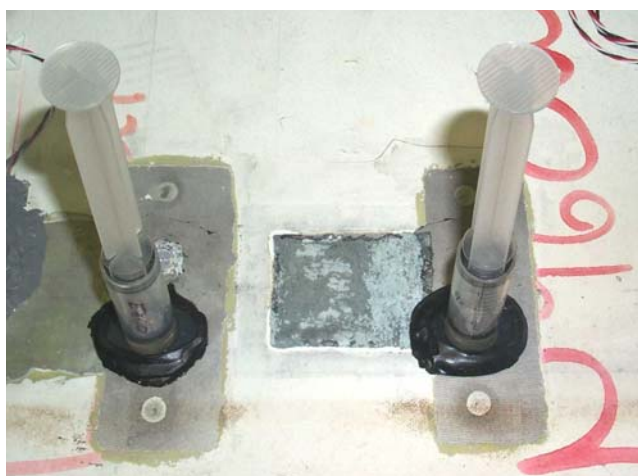
syringes in which one contained the EXCO solution while the other held the ANCIT solution and the sealant tape that was located at two fastener holes, which prevented leakage.

Figure 10-5: Typical Set-Up for Accelerated Exfoliation Protocol.

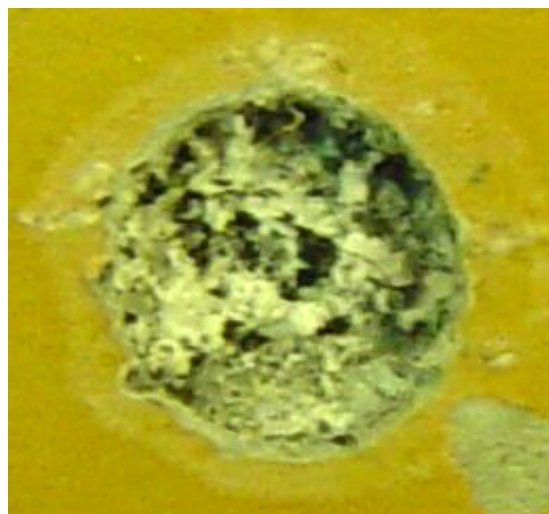
Figure 11-27(b): Corroded Pit.

Smaller features were included such as minor Surface Corrosion (SCOS) and corrosion pits (Figure 11-27). Only the area and surface corrosion sites were back-filled with corrosion product. In this case the corrosion product used was harvested from naturally occurring corrosion of identical material.

The “SCOS” damage was machined entirely by hand and the depth measured by a dial gauge with a needle nose attachment. The “Pit” damage sites were counter-bored by hand and the depth measured by dial gauge.

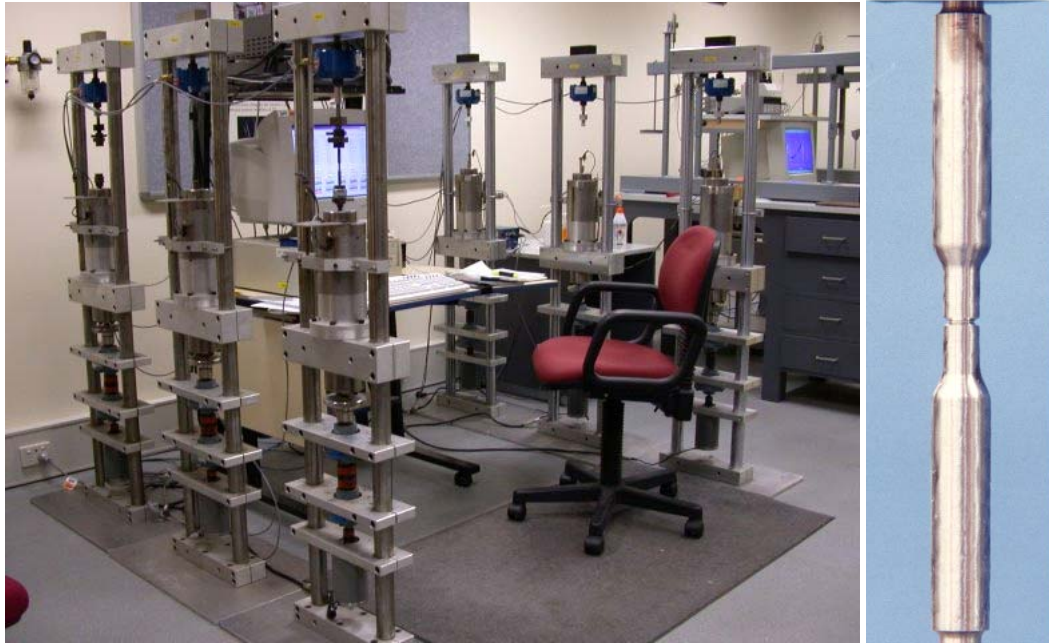
Figure 20-5 shows some SSRT test rigs and the specimen configuration. The SSRT tests are carried out to failure of the specimens and provide the notched tensile strengths or fracture stresses. These data are then compared with those of identical specimens known to be unembrittled. In addition, SEM fractography

Figure 20-5: Slow Strain Rate Tensile (SSRT) Test Rigs and Example Test Specimen.

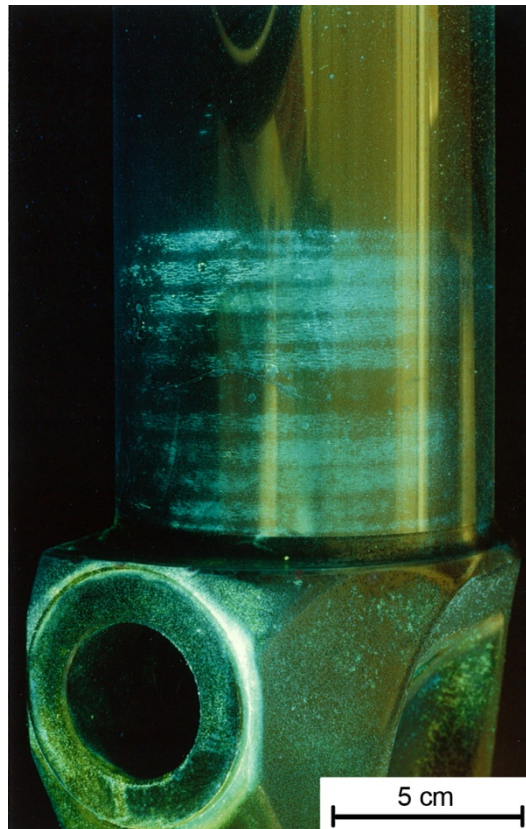
The arrowed cylindrical section in Figure 20-14 had been hard-chromium plated. Dye penetrant showed helically banded cracking at the lower and upper ends of the section, e.g., Figure 20-15.

Figure 20-15: Case History 20.5.2 – Example of Helically Banded Cracking in the Hard-Chromium Plate (see Figure 20-14 for the location).

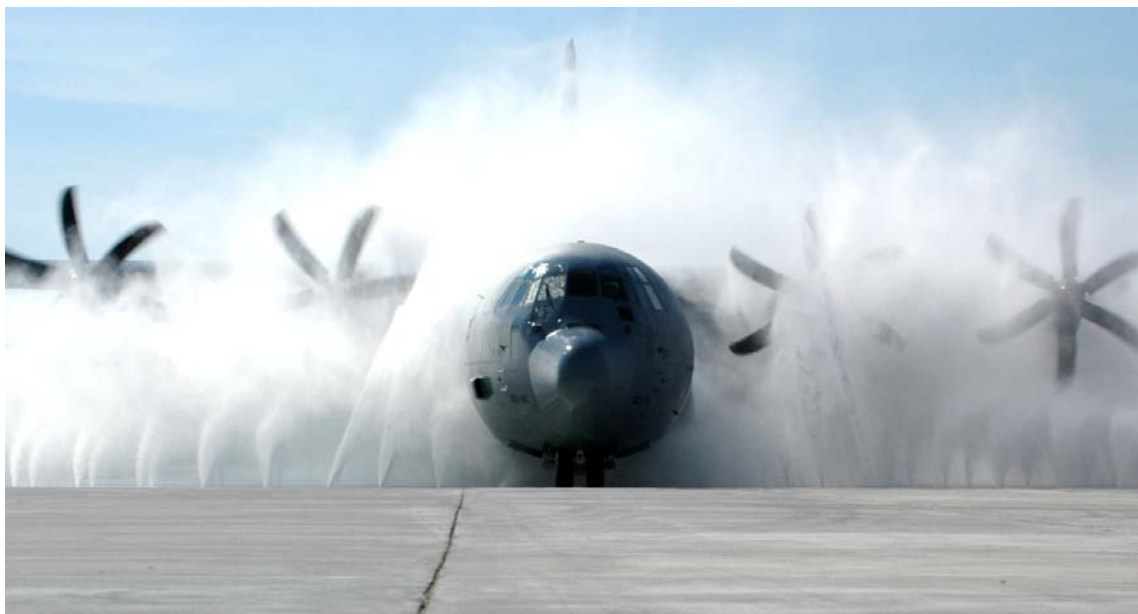
Figure 26-1: A C-130J Hercules is Cleaned Up in the New “Bird-Bath” System at Keesler Air Force Base, Biloxi, Mississippi. Aircraft from the Air Force Reserve fly many hours over the Gulf of Mexico. Salt and moisture could lead to corrosion if aircraft are not kept clean. (U.S. Air Force photo / Tech Sgt. Jame Pritchett).

Removing salt deposits on aircraft is an important component of a successful corrosion maintenance program and this is particularly true for equipment operated in marine environments. Both rinsing and washing aim at preventing corrosion damage by reducing the surface concentration of corrosive agents on aircraft exterior surfaces. While rinsing is a relatively simple operation typically carried out by taxiing through a “bird bath” upon returning from a mission, as illustrated in Figure 26-1, the washing process is much more complex and often carried out in special hangars.

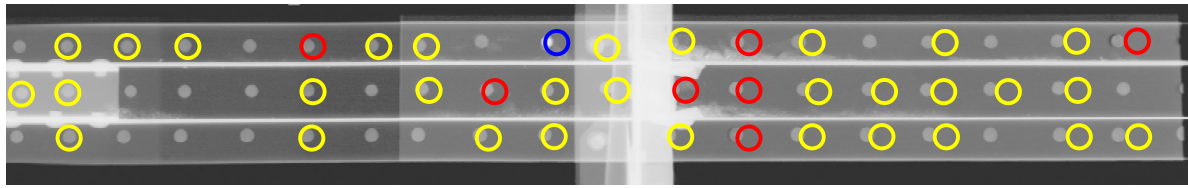
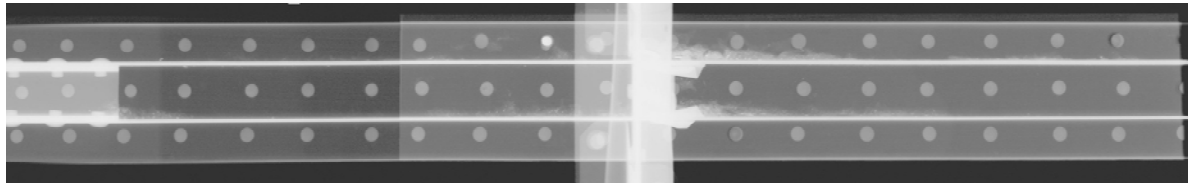
(a) Rivet damage assessment on X-Ray of intact joint.

(b) X-Ray of intact joint (same as 'a').

(c) Replaced rivet (blue circle), fractured rivets (red).

(d) DAIS view of LH end of lap joint (same as 'c').

Figure 27-5: DAIS and X-Ray Images of Left End of Joint (Figure 27-4) Showing Failed Rivets *In Situ*.

Figure 27-5 provides a closer assessment of the fasteners at the right end of the joint shown in Figure 27-4. The key for the colored circles applied to the X-ray image of the joint in Figure 27-5(a) is:

- Red – cracked around base of rivet head or head missing.
- Yellow – partially cracked.
- Blue – replacement for previously failed rivet.

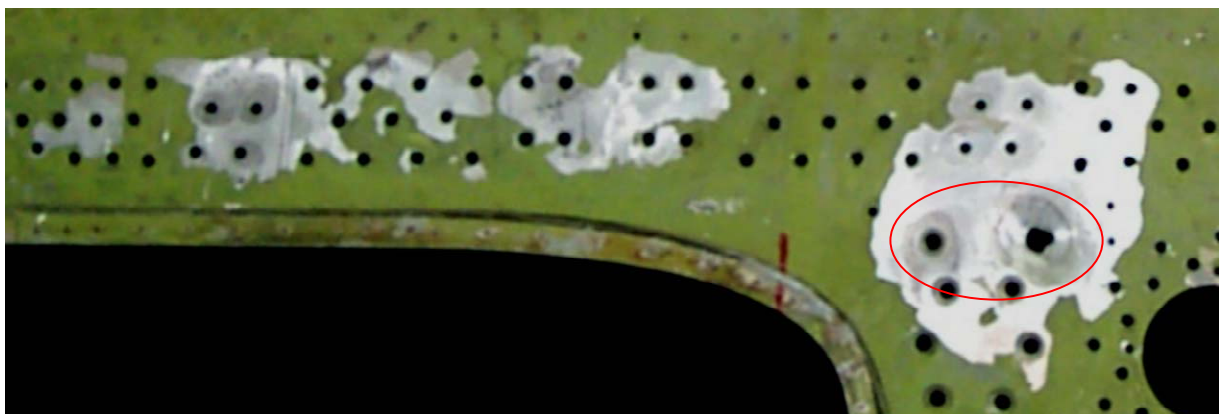
Figure 27-14: Upper Wing Skin with Exfoliation Corrosion Damage at Fastener Holes.

Figure 27-14 gives an example where severe exfoliation corrosion was removed from an upper wing skin plank. Unfortunately, the material removal and blending at two fastener holes (circled) went far beyond the allowed minimum thickness, and this resulted in the entire wing plank having to be replaced.

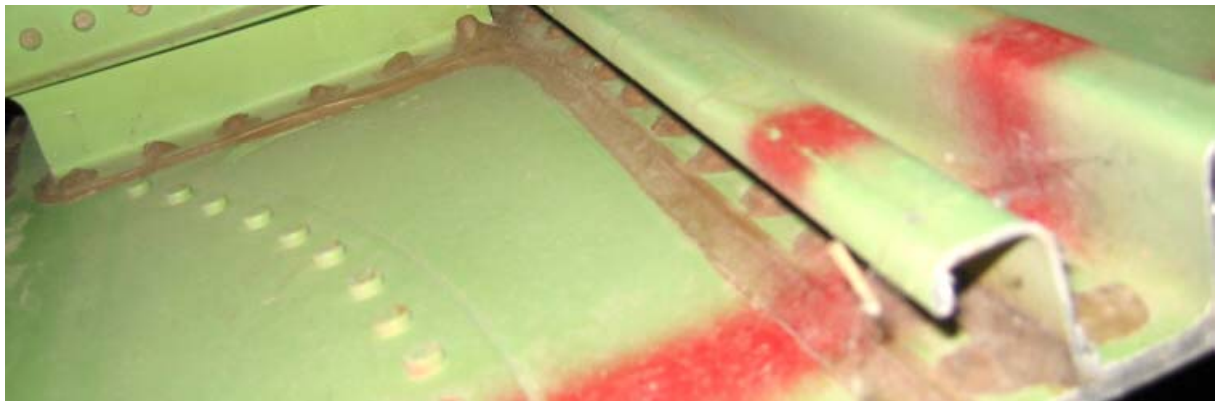
(a) Lap joint top row fasteners and stringer sealant application.

(b) View along lower surface of stringer on lap joint and body station frame attachment.

Figure 27-17: Rivet Shop Head and Stringer Edge Sealant Applications.

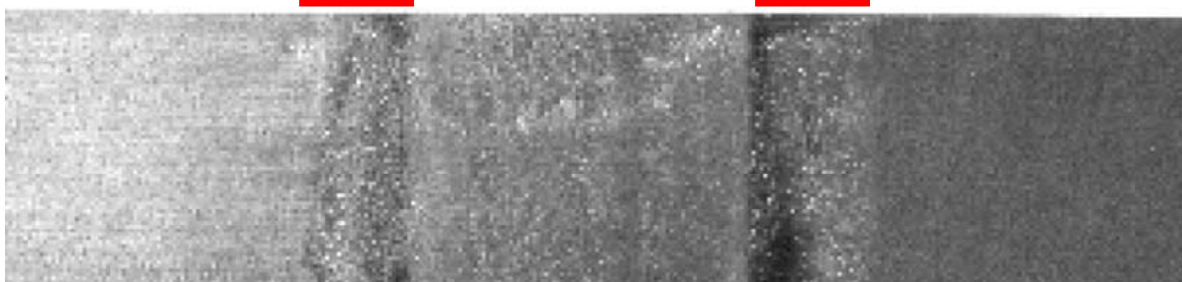
Figure 27-25: FSW Joint Structure and Corrosion Damage.

A friction-stir weld is typically characterized as being comprised of three primary zones: the Heat-Affected Zone (HAZ), the Thermomechanically Affected Zone (TMAZ), and the Dynamically Recrystallised Zone (DXZ) or weld nugget. Tensile failure in transverse tensile tests most often occurs within the HAZ or the section between the HAZ and the TMAZ. Due to the change in precipitate morphology, this region is also generally susceptible to corrosion (red lines in Figure 27-25). One way to potentially improve the resulting corrosion properties is through post-weld heat ageing treatments. Another would be to coat the susceptible surface area with another, more resistant, alloy.

(a) Cross section through joint identifying regions of the weld zone.

(b) Outer surface showing exfoliation corrosion (ASTM G-34).

The main concerns that will require additional study and testing of FSW are currently related to corrosion properties, damage tolerance properties (fracture toughness), residual stresses and the long-term stability of the joints. With respect to corrosion maintenance, simply grinding to remove the corrosion will not end

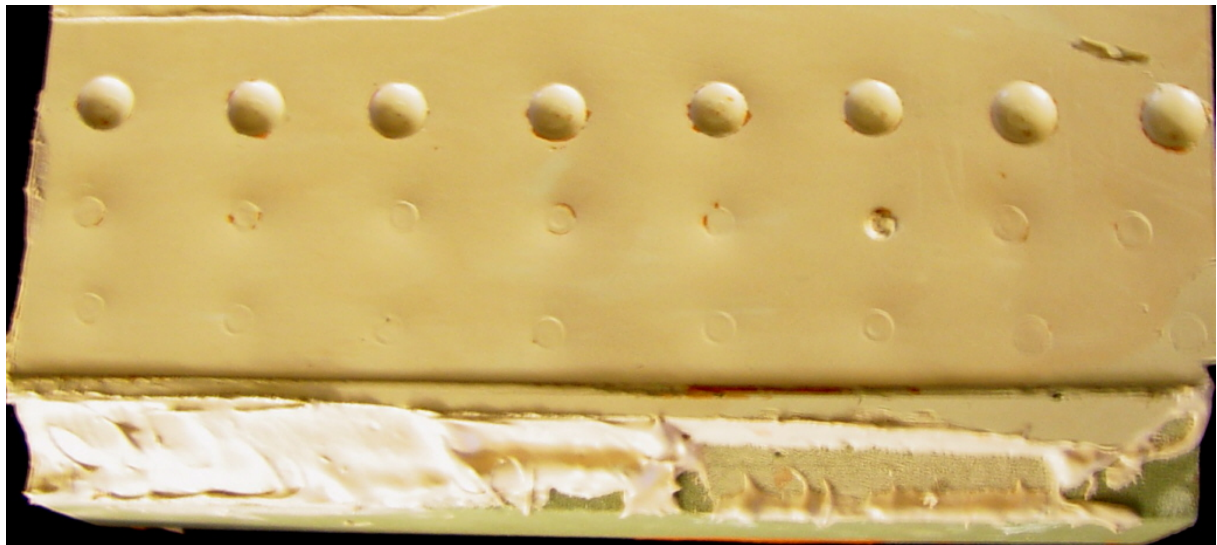
Figure 27-27: Replicas on Rigid Foam Backing of Damaged Fuselage Joints.

Physical replicas of the entire sample surfaces are impractical, and measurement data would still have to be collected. Hence surface replication is done on a smaller scale, for example parts of lap joints. Both rigid and flexible (but dimensionally stable) replicas can be, and have been, made. These provide surface topography records, e.g., Figure 27-27, which are available for investigation after teardown. For example, after disassembly it might be found useful to relate corrosion-induced pillowing (a surface topography effect) directly to internal corrosion product accumulation and any permanent deformation of the skin material.

(a) Surface replica of joint discussed in Post Teardown (Figure 27-38 – Figure 27-40).

(b) Replica of a replica recreates surface for further analysis.

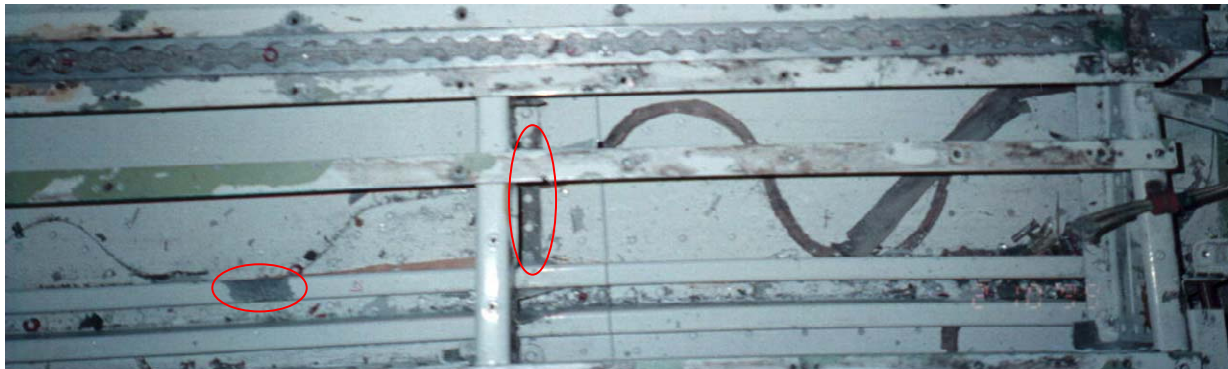
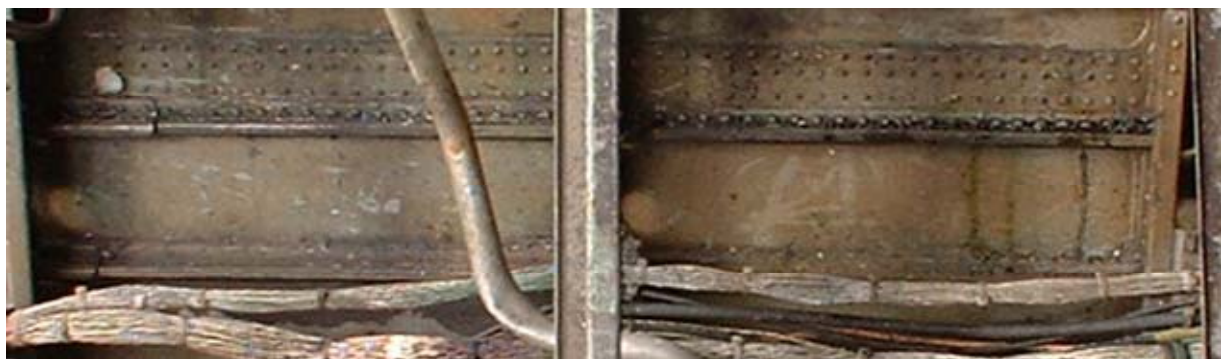
Figure 27-29: Bilge Areas Below Cargo Floor (Floor Panels and Insulation Blankets Removed).

Corrosion Prevention Compounds (CPCs) are applied internally to large areas of ageing aircraft structures. Inspections cannot be completed with these coatings in place because they accumulate dirt and debris and obscure direct viewing of the surfaces. These will often have had multiple applications of CPCs, which bind the dirt and debris in place, and the CPCs become increasingly difficult to remove as they harden with age. Another disadvantage is that the dirt-collecting nature of CPCs discolors white-painted bilges, see Figure 27-29. This discoloration reduces the visibility of corroded areas.

(a) White paint over primer (corrosion circled).

(b) White paint coated with CPC.

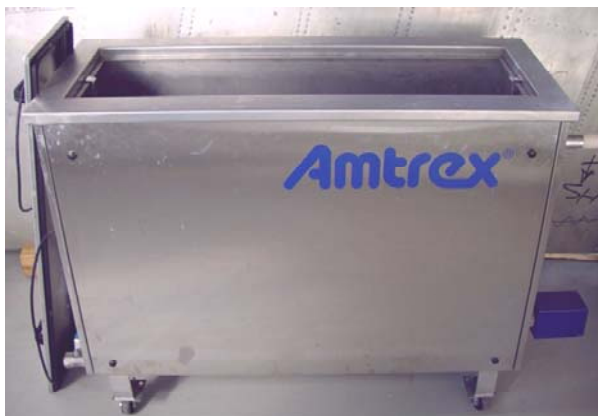
Figure 27-32: Ultrasonic Immersion Corrosion Cleaning Tank.

The method of corrosion product removal should be chosen to ensure that no additional damage is done to the structure. This is especially true if cracks are to remain undisturbed. It has been proven that corrosion product removal by chemical dissolution is greatly assisted by ultrasonic vibration in an immersion tank, for example Figure 27-32.

Ultra Kleen is a mild cleaning solution designed for cleaning corrosion products off aluminum. The solution has the following composition:

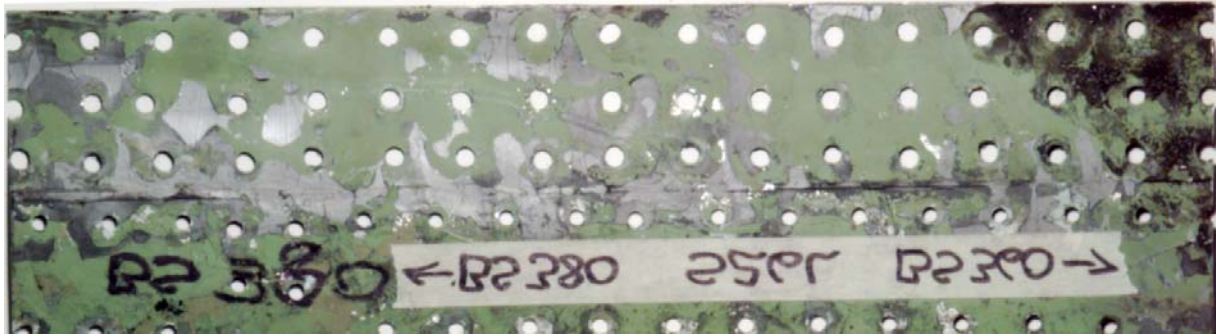
Figure 27-35: Rear Surface of Outer Skin.

The protruding-head rivets made it impossible to inspect the intact joint by eddy current NDI. Consequently the rivets were drilled out to separate the outer and inner skins. Figure 27-35 shows the rear surface of the outer skin. The black and gray areas are the remains of faying surface sealant from the prior maintenance, which had also included applying a primer. Significantly, there was no visual evidence of corrosion at the time of the teardown. This means that the pillowing observed in the DAIS inspection, Figure 27-34, was due to corrosion product accumulation up until the maintenance action, and that the subsequent visible persistence of pillowing was due to permanent deformation of the skin.

The outer skin inner surface shown in Figure 27-35 was cleaned chemically to remove the sealant and primer. This was followed by X-radiography that included a ramped master calibration tool to enable thickness measurements. The NRC/IAR NDI Analysis™ software was used to obtain the calibration and skin thickness measurements from the digitized image file of the X-ray film, Figure 27-36.

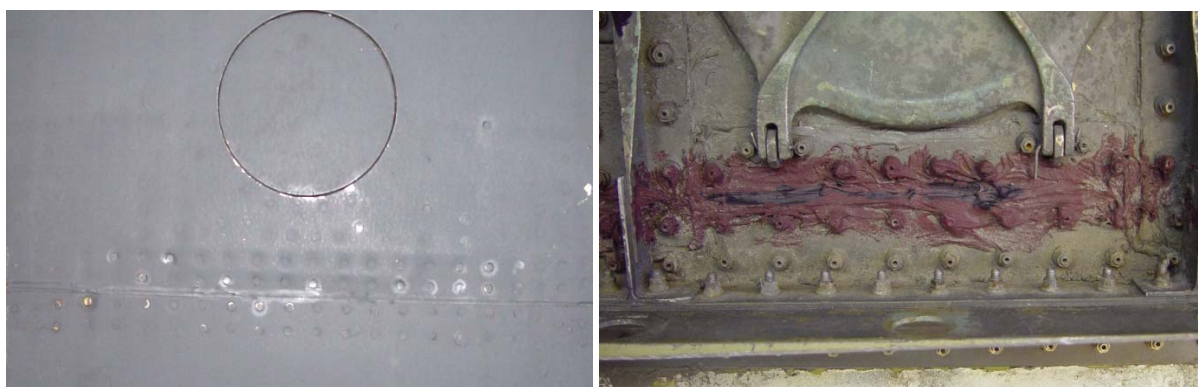
Figure 27-38: A Visual Inspection of the Exterior Surface Indicated Corrosion Pillowing (left) While the Interior Showed Sealant Added (red) Indicating Maintenance for Same (right).

Field inspection of a C-141 airframe located classic visual evidence for corrosion induced pillowing at the joint on Stringer 32 Right, see the left-hand photograph in Figure 27-38. The skin was buckled between the steel fasteners (Hi-Lok® HL19, 100°, Reduced Flush, shear bolts), and some fastener heads were being pulled through the outer skin. Furthermore, this damage was at a known corrosion site, below the sewage access port for the hospitality pallet. The right-hand photograph in Figure 27-38 shows that sealant had been added to the original protection scheme on the inner surface, indicating maintenance for corrosion damage.

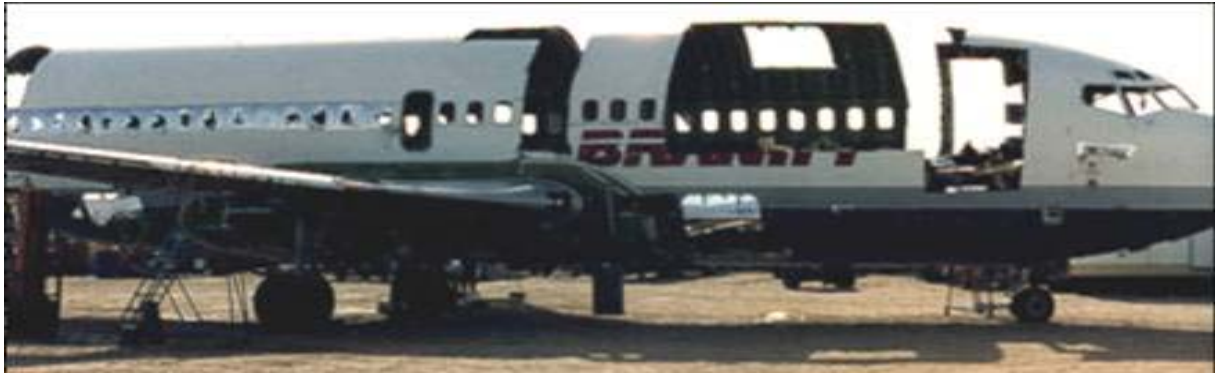
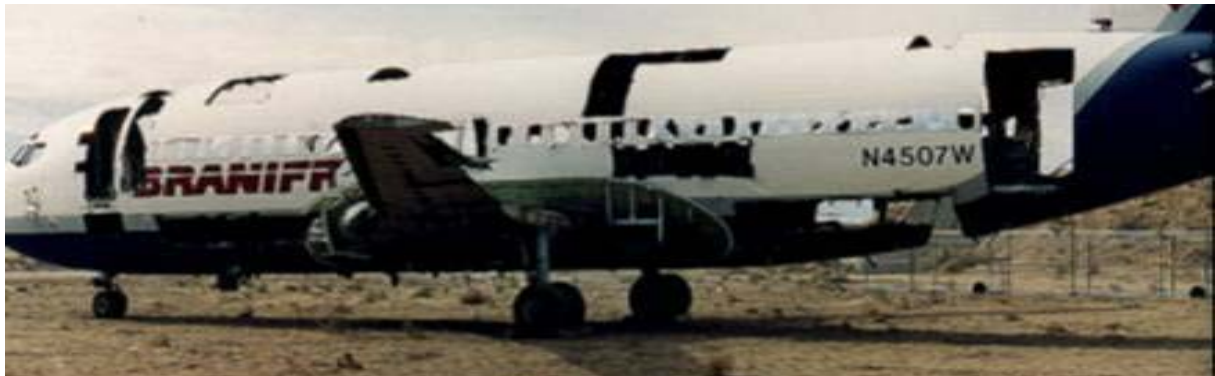
Figure 27-42: Cut-Outs Show where Fuselage Structure was Harvested from WFU Airframes.

If possible, both naturally damaged and pristine structures are collected. The usual sources for these original components have been wrecks and airframes Withdrawn From Use (WFU), see Figure 27-41 and Figure 27-42. Operators of new designs have been known to purchase additional airframes intended as immediate sources of spare parts, but these can also serve as sources for materials and assemblies.

Note from Figure 27-42 that these WFU aircraft are parked in desert environments. Actually, deserts are *not* the best places to store aircraft that have been in service. It has been assumed that the arid climate minimizes corrosion activity. This may be true for the exterior surfaces, but experience has shown that the closed-off internal environments still support corrosion processes, and the high daytime temperatures may well accelerate them. Consequently, desert storage areas have proven to be productive sources of examples of service and post-service corrosion, Figure 27-43 and Figure 27-44.

From nose to tail and top to bottom the materials, structural elements and assemblies of transport aircraft fuselages generally remain the same. The upper and lower wing skins are usually made from different alloys (7XXX upper skin, 2XXX lower skin) and they vary in thickness from root to tip. However, apart from these differences both fuselage and wing structures can be sampled for collection, i.e., it is not necessary to obtain entire airframes. Figure 27-42 illustrates that the samples can be relatively small.
